## DIGITAL PHOTOGRAPHS

**Date:** March 17, 2010  
**Time:** 9:29 a.m.  
**Direction:** W  
**Photo by:** Charlie King  
**Exposure #:** 001  
**Comments:** The east side of the Nutronics building facing Peoria Road.

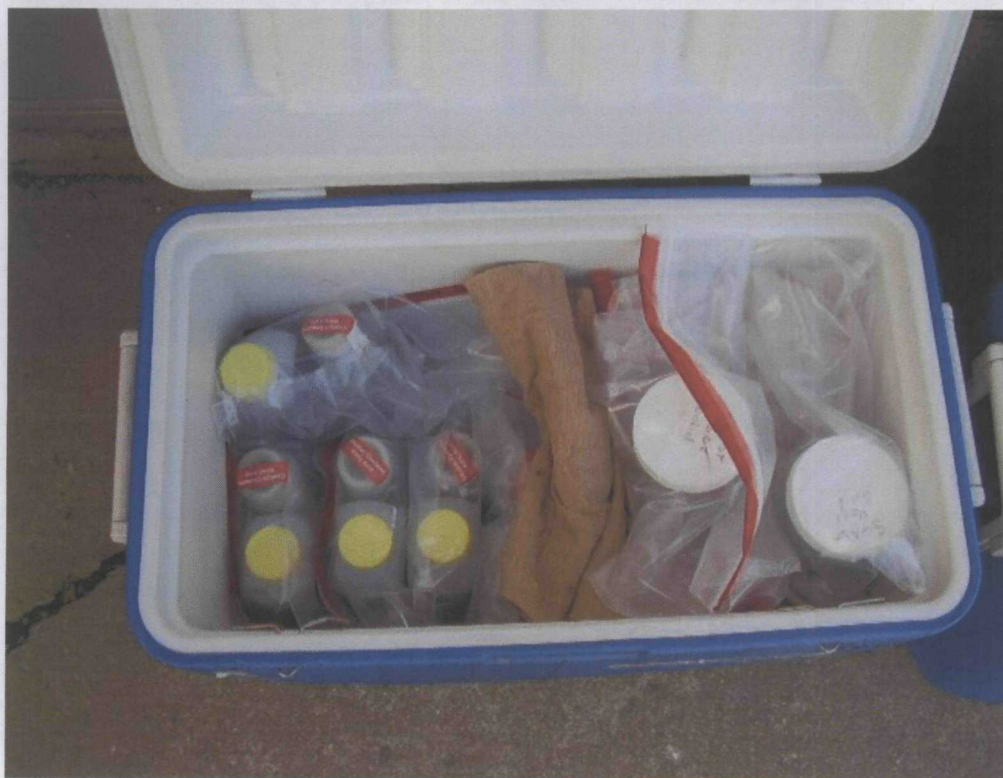
Date: March 17, 2010  
Time: 3:26 p.m.  
Direction: S  
Photo by: Paul  
Eisenbrandt  
Exposure #: 052  
Comments: Waste  
samples packed in  
sealed bags inside  
coolers.
